# HAN1100 Ultimate Addendum

It has come to our attention that two measurements listed in the Ultimate manual are incorrect. This addendum corrects this issue by providing the correct measurements for the axle location on the wheel pant and the centerline on the firewall.

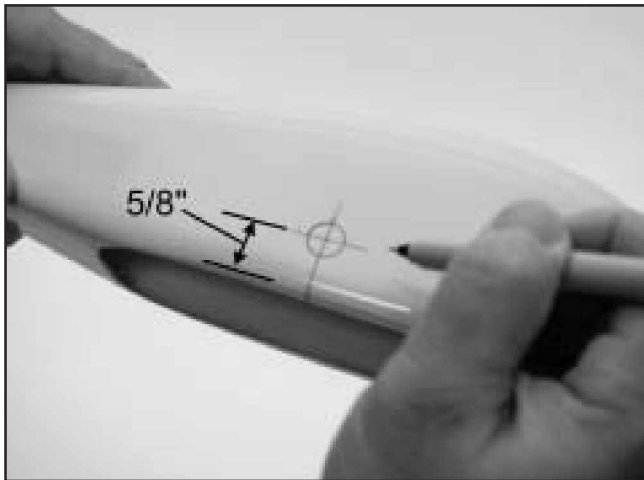
## Page 42, Step 3

The measurement for locating the axle on the wheel pant is incorrect. The step should read as follows:

Measure and mark the location for the axle on the wheel pant. The center of the axle will be located  $5/8$ " up from the bottom of the pant. Drill the location using a  $1/2$ " drill.

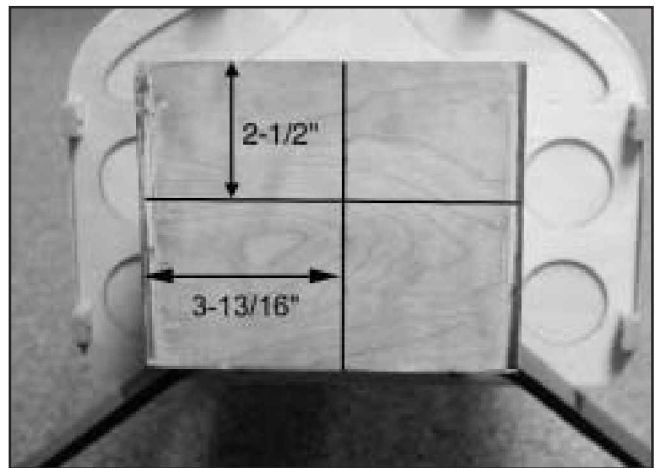
## Page 56, Step 2

The photo for drawing the centerline on the firewall has the measurement referenced from the wrong side of the engine box. The correct wording and photo are as follows:

Draw a vertical and horizontal centerline on the firewall. The horizontal line is located  $2\frac{1}{2}$ " from the top of the firewall, and the vertical line  $3\frac{13}{16}$ " from the left side of the firewall, as viewed from the front.
